Country	MIKAS springs	Coordinates / Nearby City	Spring discharge (Q in l/s,min/av/max) / tapped or not	Criteria* in order / Main justification */ H-historic, A-aesthetic, S-scientific, E-Economic, Ec-ecologic	Data collected by
Brazil

MIKAS - Baía Bonita

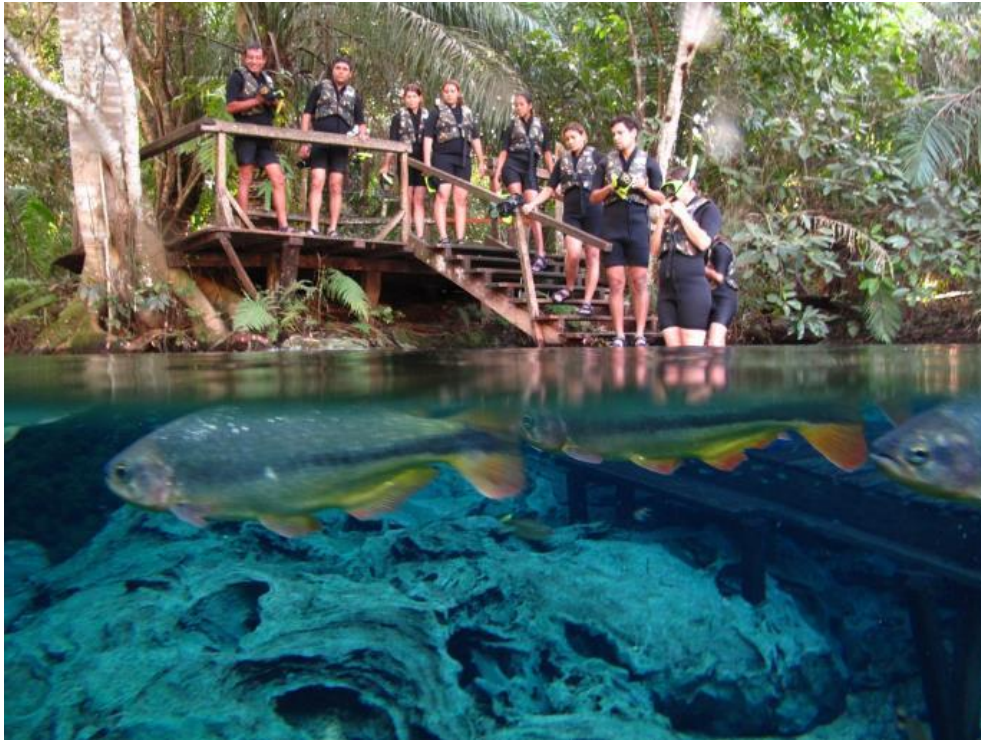
View of Baía Bonita Spring. From: www.aquarionatural.com.br

1. Baía Bonita	S 21°09'45" W 56°26'24" Z = 265 m asl Bonito	No discharge records Not tapped	A, E, S, Ec <i>The best known springs in the Bonito area. The crystal clear water and the very rich aquatic fauna makes it one of the favourite touristic spots in Bonito with large number of visitors. It generates significant income for the local managers and the tourism industry. The site is known for its sustainable approach to tourism and for pursuing ecological values. It is located inside privately owned ecological reserve.</i>	Augusto Auler, Paulo Boggiani

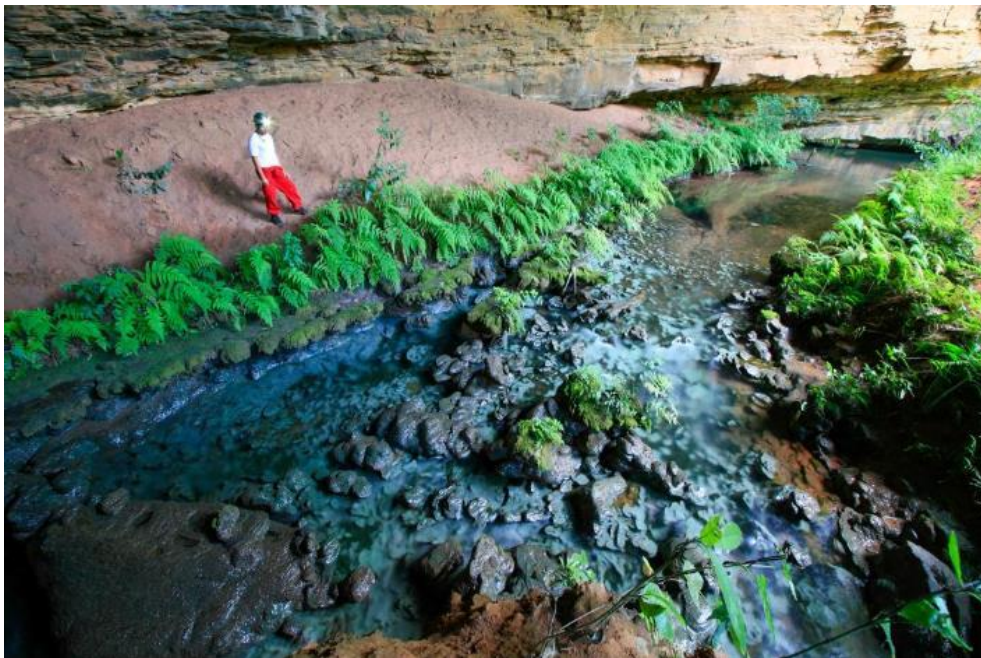
MIKAS - João Baio

View of João Baio spring (Photo by Alexandre Lobo)

2. João Baio	S 12°22'28" W 44°53'31" Z = 622 m asl São Desidério	538/1110/? Not tapped	S, A, E, Ec, H <i>Being the only rhythmic (ebb and flow) spring known in South America, and among the few in the world make this spring most important to understand the mechanisms behind such remarkable and short (minutes) cycles of discharge variation. It is a scenic spring, located amidst a forested zone. The spring was brought to the attention of scientists just a few decades ago. No earlier descriptions are available.</i>	Augusto Auler, Lucas Padoan

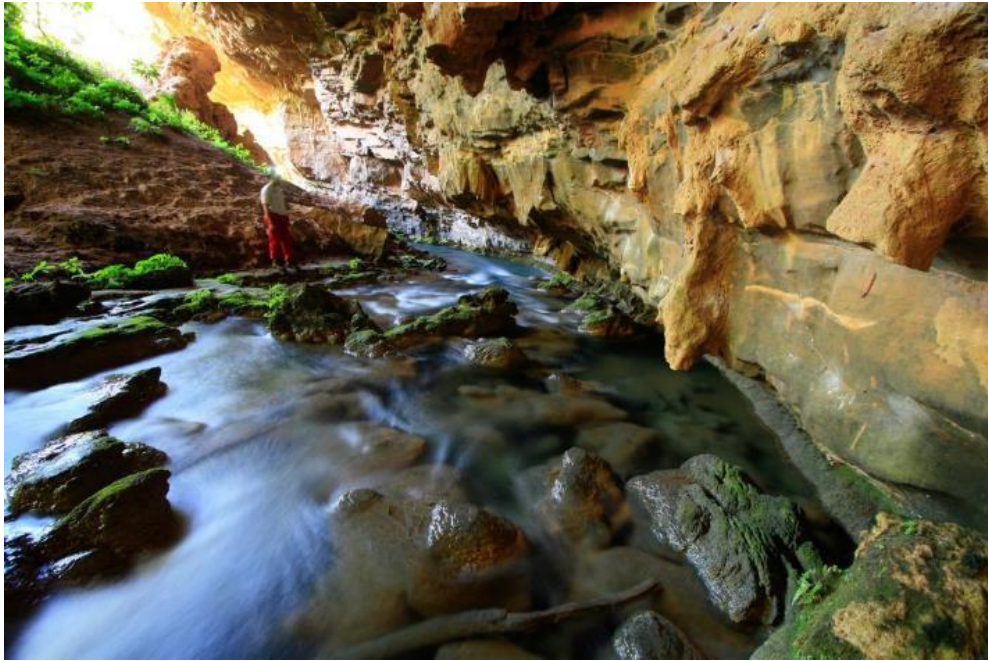
Cycle of discharge variation few meters downstream from the spring. Low discharge (Photo by Alexandre Lobo)

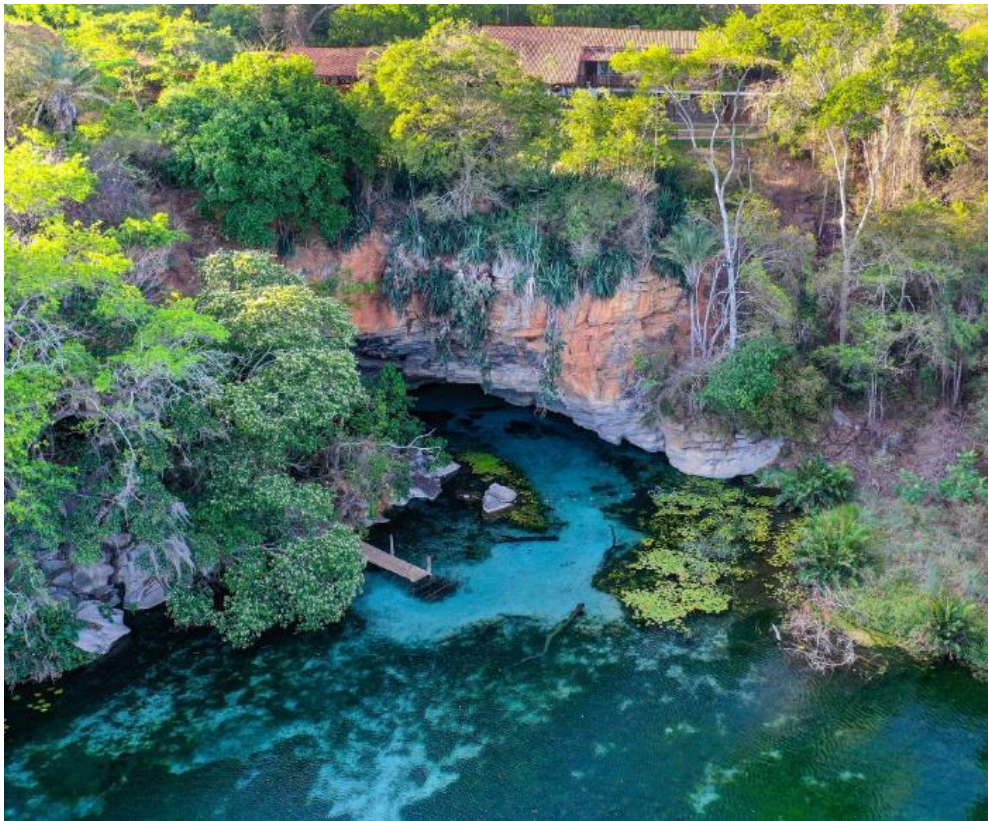
MIKAS - Pratinha

Aerial view of Pratinha Spring (Photo by Alexandre Lobo)

3. Pratinha	S 12°21'09" W 41°32'26" Z = 642 m asl Iraquara	751/859/1222 Not tapped	A, H, E, S <i>The crystal-clear water (Pratinha means "little silver") is very scenic and contrasts sharply with the grey aspect of the local vegetation. The spring has historical value, since it was described in the 19th century and since then has become an important landmark in this mostly arid region. The spring is in private property and is operated as a water park. Only basic hydrogeological characterization has been performed so far.</i>	Augusto Auler

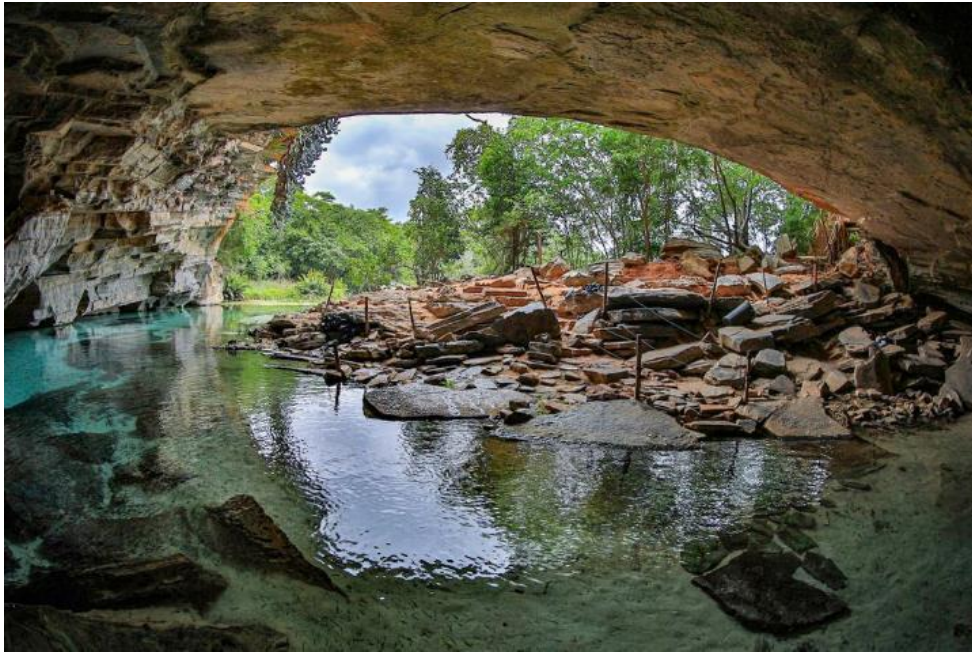
View from the interior of the cave where the Pratinha spring issues (Photo by Alexandre Lobo)

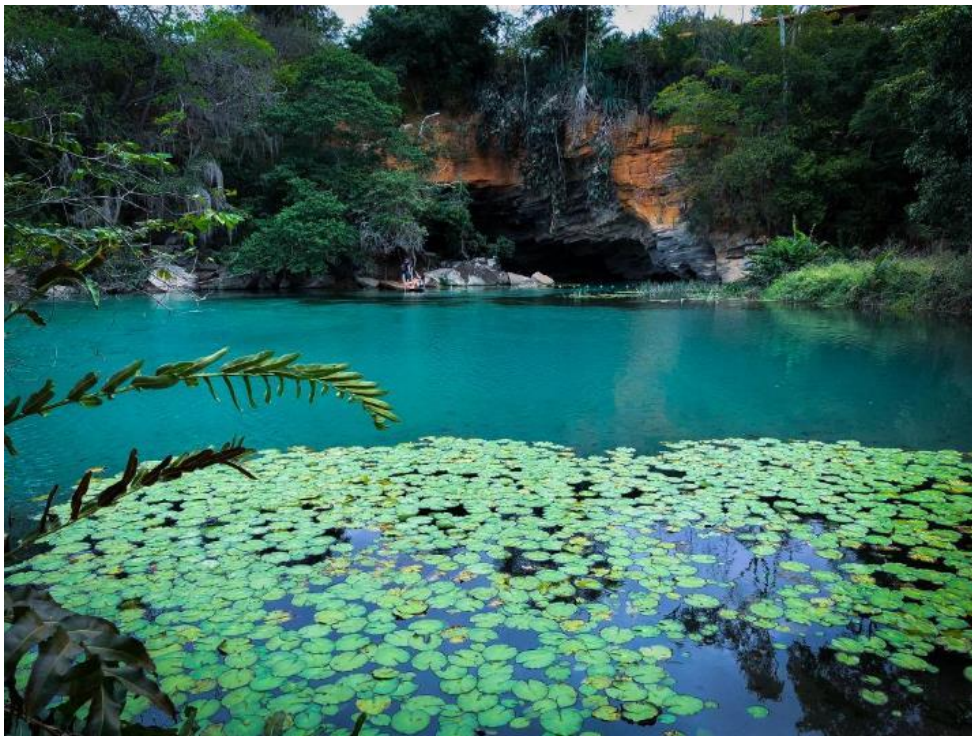
View of the lake in front of the spring with the cave in the background. This lake is used as a water park (Photo by Alexandre Lobo)
